Manhole Inspection Summary

Manhole # S27C__048MH

Insp Date: **11/29/07 1:38 PM**

Location Address: **323 FREMONT AVE**

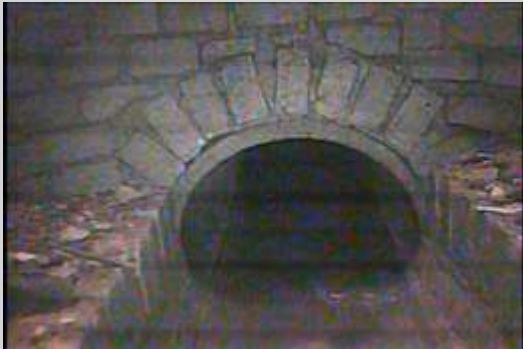
12 O'Clock Outflow

Pipe Height: **15.6** (in.) Rod and Bar (Angled)
Pipe Material: **Clay** ☐ Pipe Lined
Invert Depth: **14.56** (ft.) Flow Characteristics: **Slow**
Deposits: ☒ None ☐ Mud ☐ Sludge ☐ Debris ☐ Grease
Silt Depth: (in.) Deposits Extent:
Infiltration: **None** Pipe Seal Cond: **Sound**

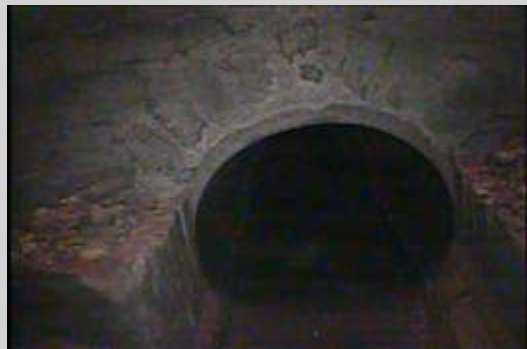
6 O'Clock Inflow

Pipe Height: **15.6** (in.) Rod and Bar (Angled)

Pipe Material: **Clay** ☐ Pipe Lined

Infiltration: **None** Pipe Seal Cond: **Sound**
